Din Sync

RE-909

Additional Advisory

RE-909 Additional Advisories:

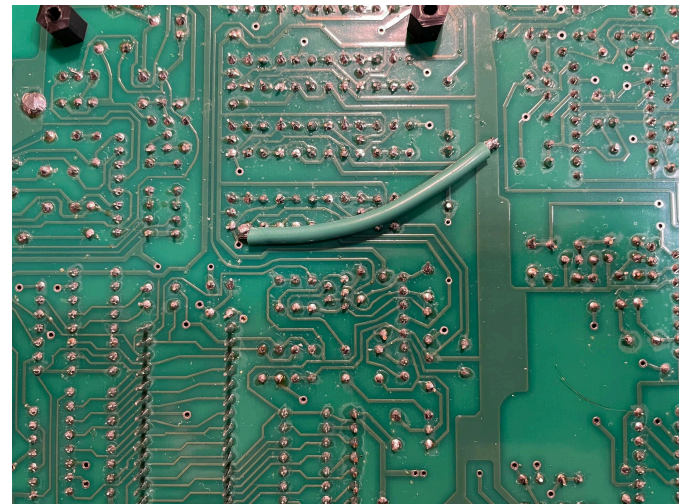
1- OVERALL GROUND ISSUE FIX - GROUND & CROSSTALK FIX

Hi, just wanted to share some good news about noise and crosstalk issues on RE-909. Pictured below is a Roland TR-909 factory mod with a wire that seems to reinforce grounding between C151 styrofoam cap in the hihat low pass filter and the common analog ground track where R236 is also attached. By doing the same mod in RE-909, pictured below also in the bottom of the board, cymbals crosstalk and digital noise leak into the hihats channel is eliminated, which fixes the last remaining issue in my build. I used a thick grounding wire to connect the lower pin of C151 to the double hole in the common ground track next to R236. This fix works perfectly on trafo PSU but I can't guarantee it works on safe PSU (and preliminary tests show it doesn't) because of the difference in ground routing. Otherwise, enjoy your digital noise-free, crosstalk-free RE-909!

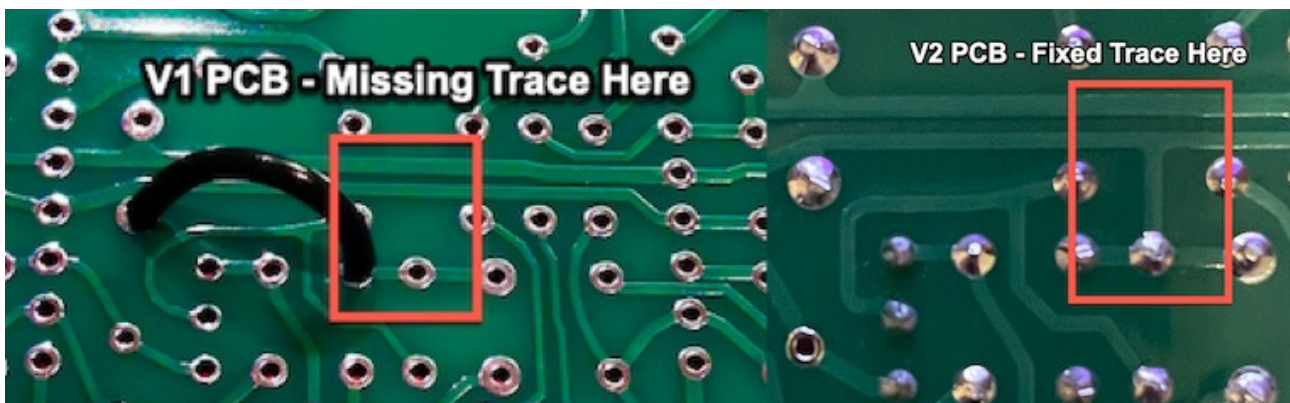
5 - SD ENVELOPE FIX

RE-909 service advisory 15-12-20

We found a minor error in the snare drum that didn't come up in testing. Its a simple fix with a single patch wire, please download v.1.7 build documentation for details.

Fixed in voice boards V2
