# RE-909

## Additional Advisory

# RE-909 Additional Advisories:

v0.1F

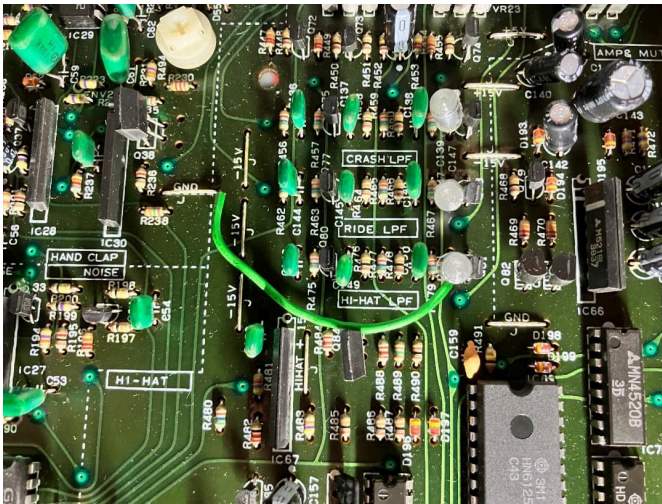
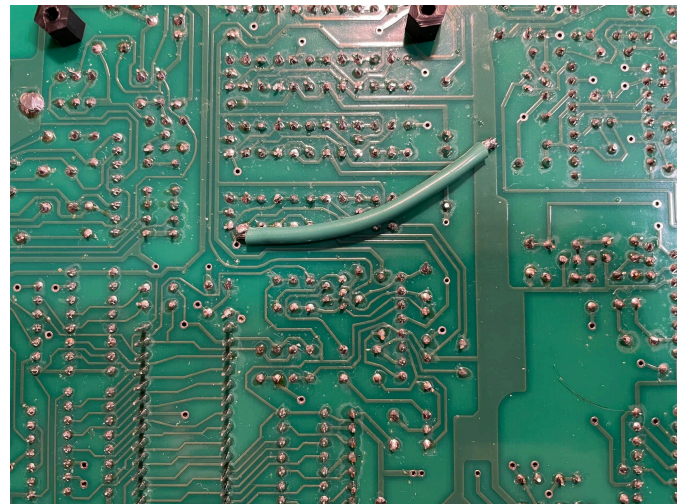
## 1- OVERALL GROUND ISSUE FIX - GROUND & CROSSTALK FIX

Hi, just wanted to share some good news about noise and crosstalk issues on RE-909. Pictured below is a Roland TR-909 factory mod with a wire that seems to reinforce grounding between C151 styrofoam cap in the hihat low pass filter and the common analog ground track where R236 is also attached. By doing the same mod in RE-909, pictured below also in the bottom of the board, cymbals crosstalk and digital noise leak into the hihats channel is eliminated, which fixes the last remaining issue in my build. I used a thick grounding wire to connect the lower pin of C151 to the double hole in the common ground track next to R236. This fix works perfectly on trafo PSU but I can't guarantee it works on safe PSU (and preliminary tests show it doesn't) because of the difference in ground routing. Otherwise, enjoy your digital noise-free, crosstalk-free RE-909!

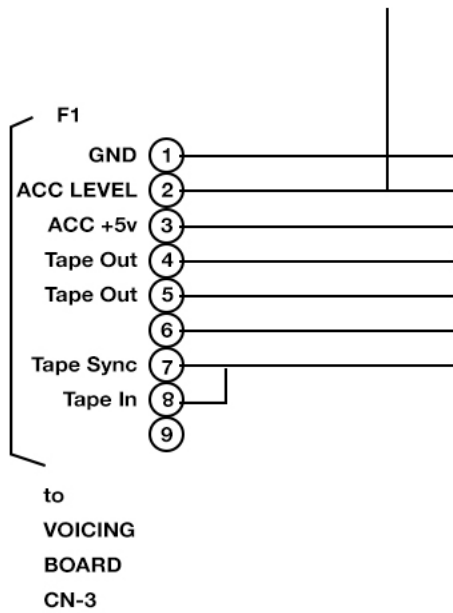
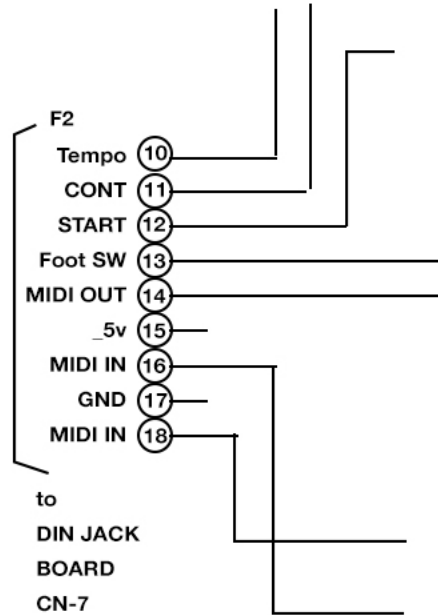
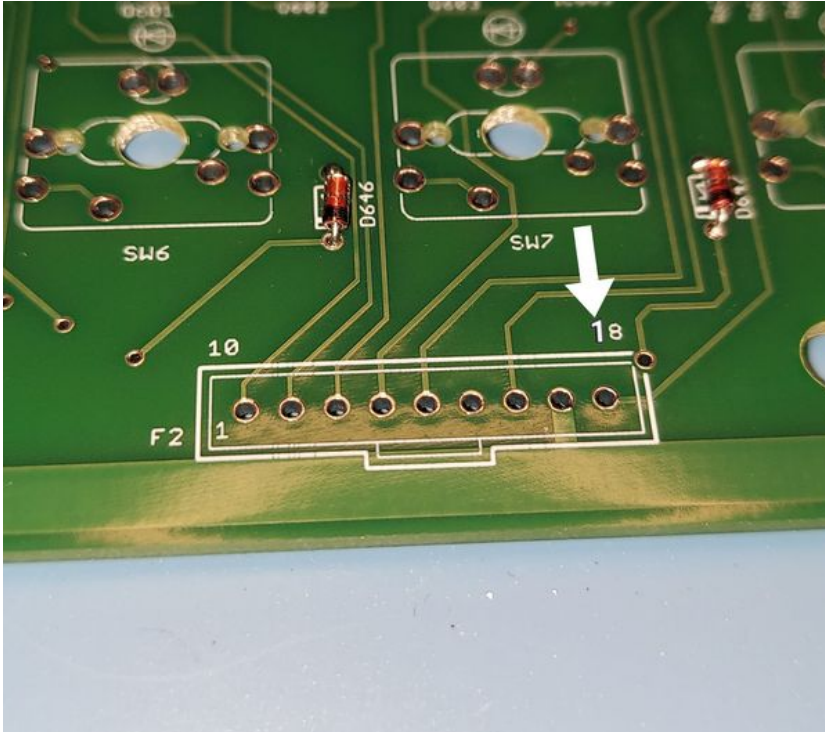
### 3 - SWITCHBOARD PCB ERROR

The pin numbers of the switchboard connectors were incorrect on the initial run. See the pin out/destination diagram from the service notes (above) and be sure of your pins and destinations on your switch board (below). Check twice, solder once.

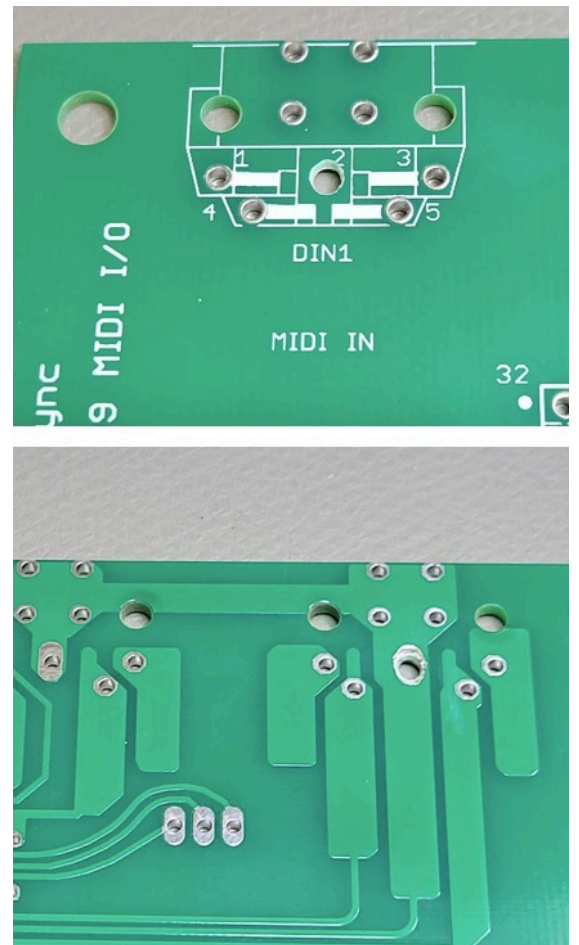
## 4 - MIDI IN PCB ERROR

We have noticed a small problem on the midi board, pin 2 from the midi in port is connected to ground and under certain circumstances this can lead to a buzz/hum when midi in is connected. Paul is going to update the build docs, here are photos of two possible ways how to fix it (not soldering pin 2 might be sufficient if it doesn't touch the pad):

1. Use a dremel or round file to remove the pad/increase the diameter of the hole to make sure pin 2 isn't connected to gnd or clip/remove pin 2 from the midi socket before soldering it
2. if you have already built the midi board and don't want to desolder the socket, cut a trace at 2 points and use a jumper to connect ground to pin 17 of the connector

### SUGGESTED:

**desolder the midi socket, lift (or cut) and isolate pin 2 and solder again.**

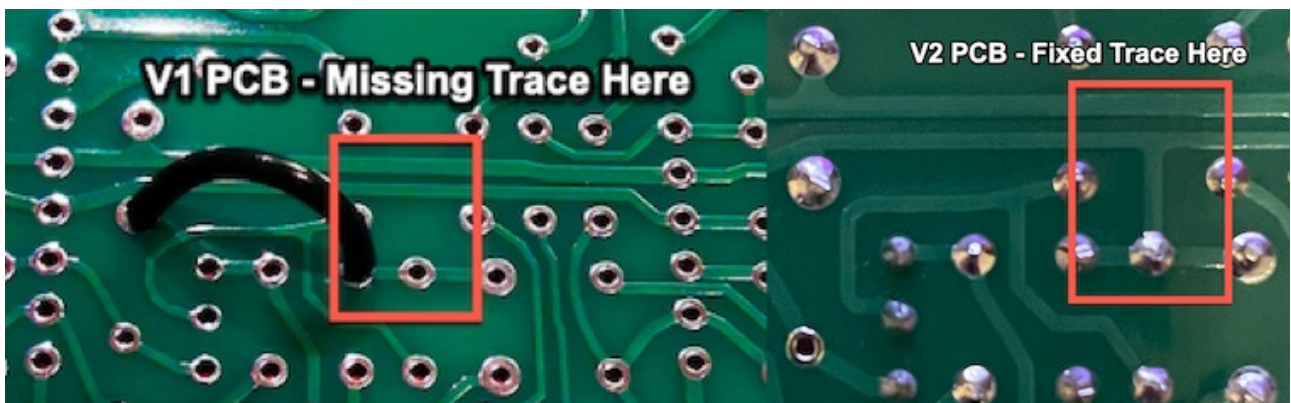
## 5 - SD ENVELOPE FIX

We found a minor error in the snare drum that didn't come up in testing. Its a simple fix with a single patch wire, please download v.1.7 build documentation for details.

Fixed in voice boards V2
